Carquinez Replacement Bridge Project

Report of Potential Construction Impediments Observed in the Maritime Archaeology Remote Sensing Survey and Ground Truthing Operations

**Prepared by:
William Self Associates
Orinda, California
December 1999**

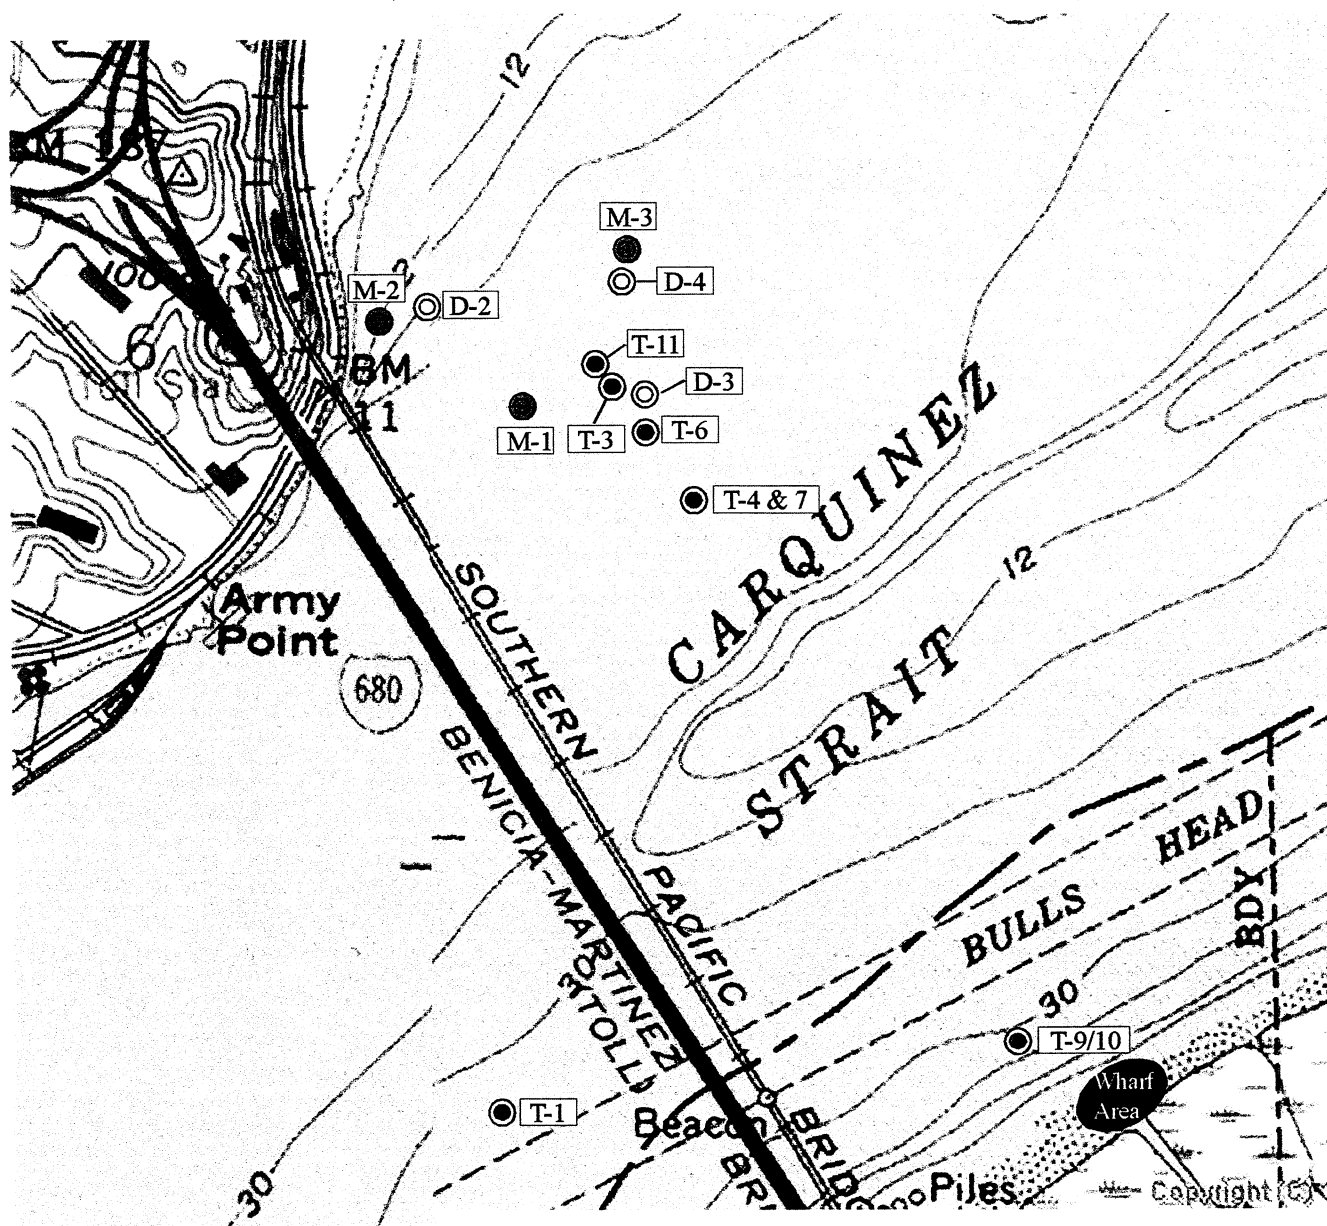
Figure 1

The locations and coordinates of the 14 potential construction impediments identified during the remote sensing survey are depicted in the appended map and table (Figures 1 and 2). As noted below, copies of side scan sonar records, and line drawings depicting the estimated configuration of several of the more noteworthy targets are appended as well.

To the southeast and immediately adjacent to these two targets is an array of wood piles associated with an abandoned pier that once projected from the south shore of the Carquinez Straits. Although not submerged impediments, as a point of information these piles should be avoided until they have been properly assessed. Such an assessment will be conducted in May 2000 (refer to Figure 1).
